Manhole Inspection Summary

Manhole # S45I__062MH

Insp Date: **4/24/08 11:12 AM**

Location Address: **318 s castle st**

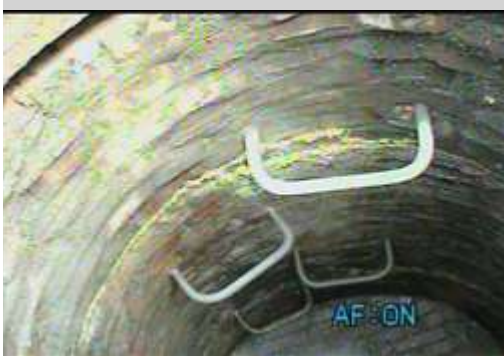
Defect 1

Condition: ☐ Sound ☐ Cracked ☐ Root Intrusion ☒ **Loose Brick** ☒ **Deteriorated**

Steps Count: **4** Missing: **0** ☒ **Corroded**

corroded stairs, corbel loose bricks & deteriorated

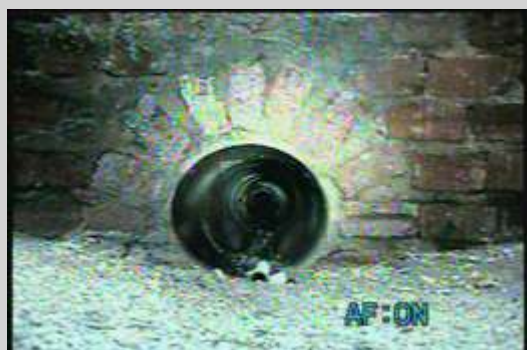
12 O'Clock Outflow

8 in. Circular Gravity Sewer
Pipe Out @ 12 O'Clock
